ST. JOHN'S FOUNDATION

THE EHRICK ROSSITER STONE CHURCH RENOVATION PROJECT

FIRST STEPS – February and March, 2024

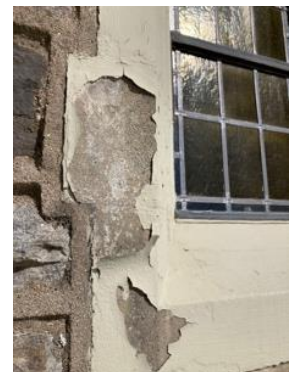
Visual inspection of the exterior window surrounds along the outside of the nave suggests that the cast-stone used for the surrounds may mostly be in good shape, but the coating that has been applied in successive layers is peeling. So most, at least, of the window surrounds themselves seem not to need replacement in order to undertake the window project, but they do look a mess.

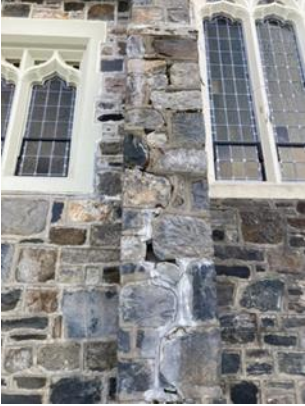
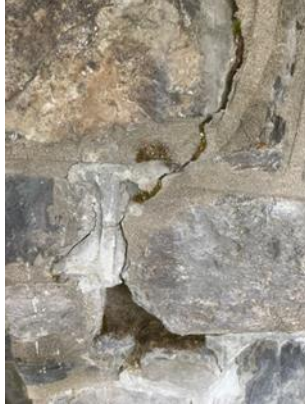
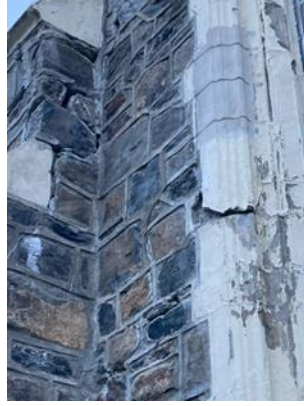
However, even a cursory viewing of the church's wall surfaces reveals significant deterioration. In some areas, what appear to be large cracks run along the joints between stones (see top of next page).

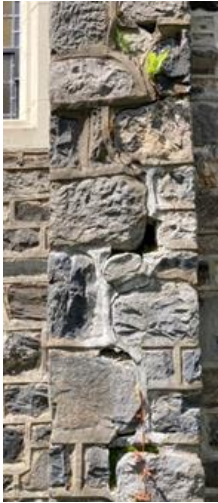
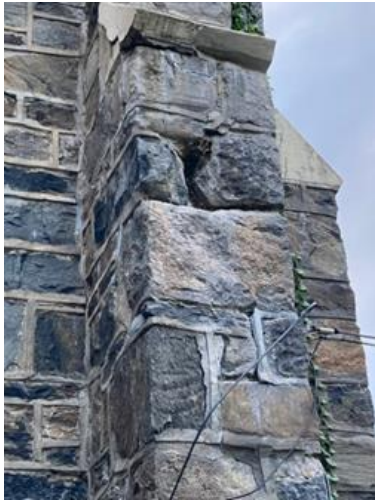
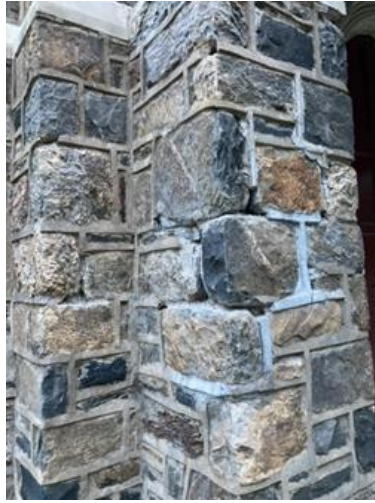
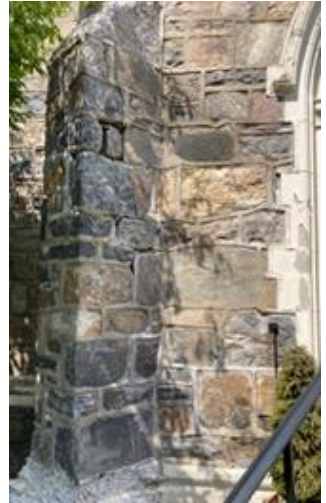
In other places, gaps both large and small appear between stones.

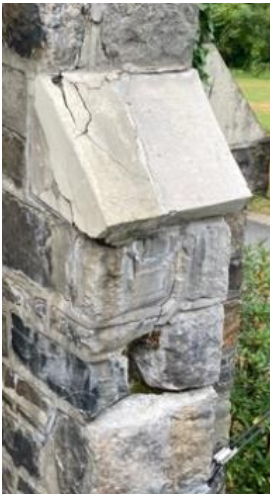
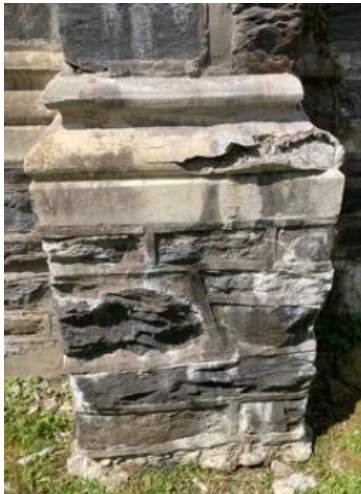
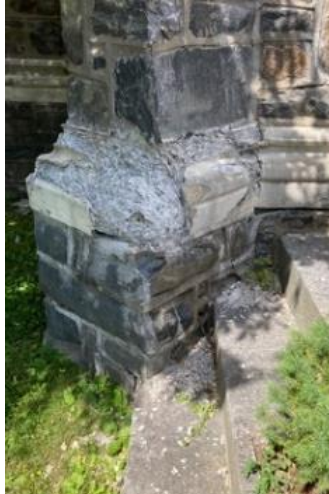
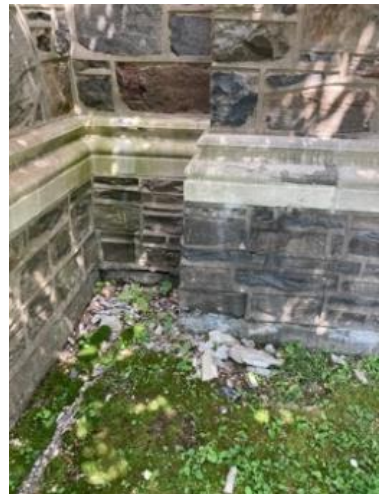
Several of the cast-stone coping elements and whole sections of the cast-stone water table are spalling, or crumbling, leaving piles of detritus and dust on the ground beneath them.

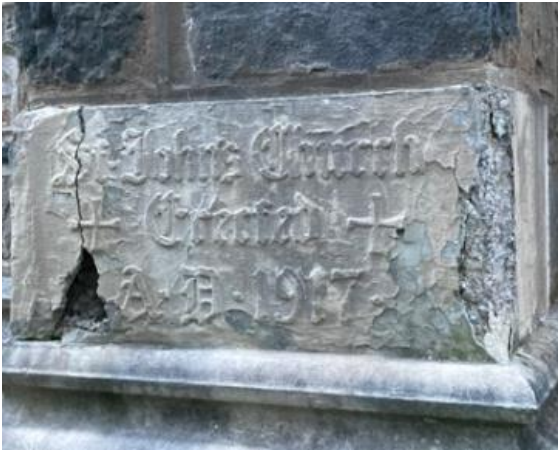
The church's cornerstone approaches ruinous condition.

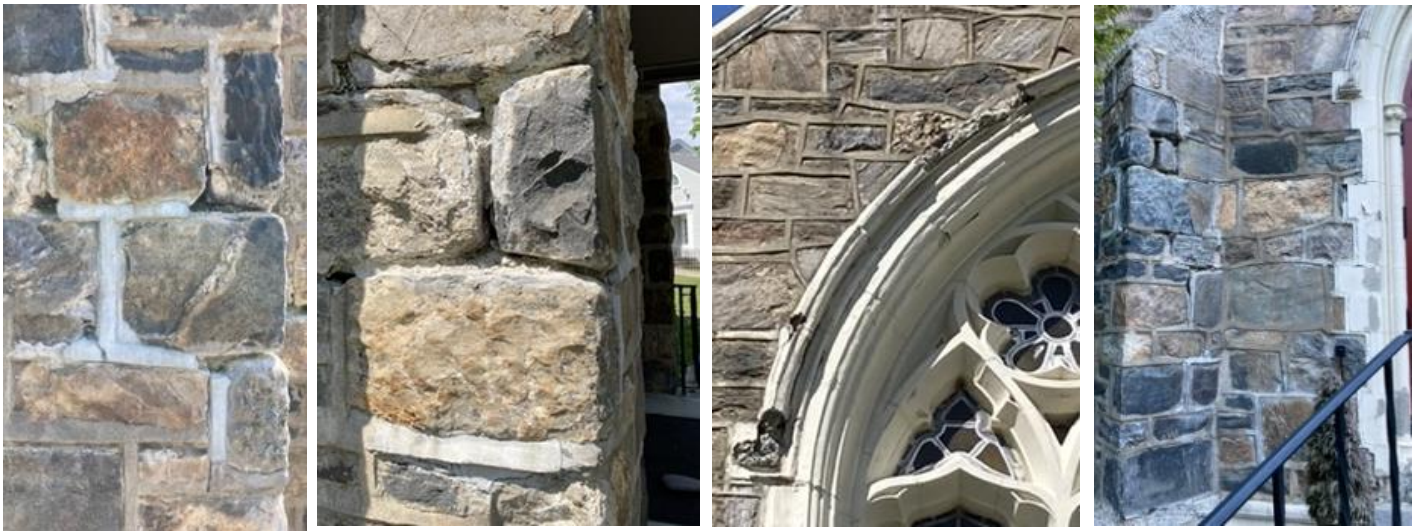
Although the nature, extent and cause of the damage are unclear from visual inspection alone, it is glaringly obvious that the alarming condition of the church requires immediate attention.

This leads to a reevaluation of priorities: the prospective restoration of stained-glass windows in the nave is put on the back burner, and the St. John's Foundation turns its attention instead to the masonry fabric of the church structure.

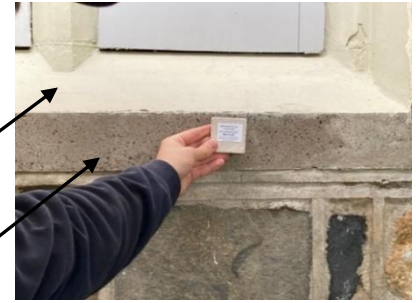
Successive layers of coatings have been applied to all cast stone elements at some time in the past, and it is deemed likely that these coatings have contributed significantly to the present state of deterioration. Although they may have originally been applied with the goal of repelling water, they have probably had the contrary effect of trapping moisture in the structure of the stone wall. (They may also have been applied for aesthetic reasons, such as visually setting off the windows from the wall surfaces.)

In the photo to the right, one can see both the layers of coating on the cast stone of the exterior chancel window and a section at the bottom that has been cleaned to reveal the original.

Coated section of original cast stone

Cleaned section of original cast stone

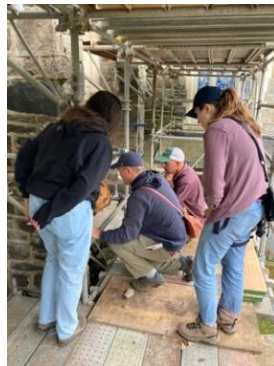
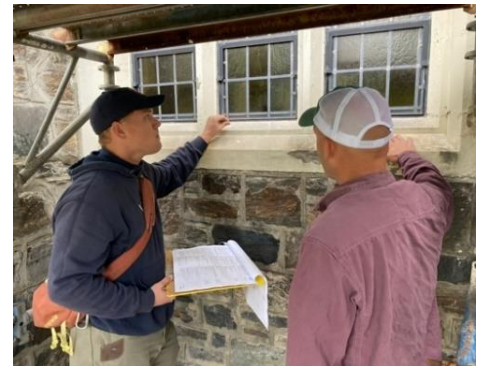
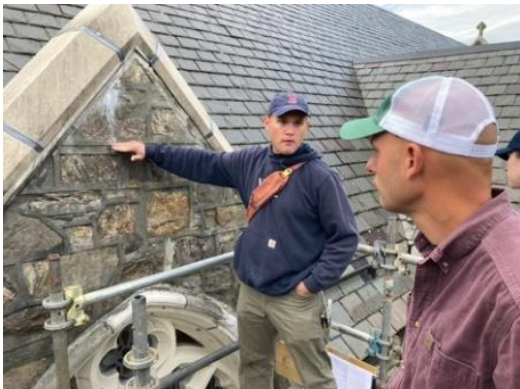
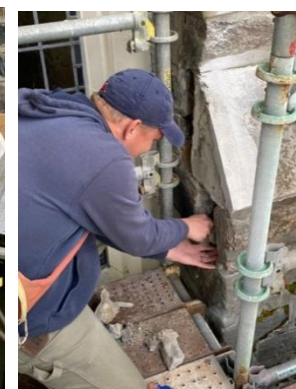
Meeting with WJE and BPM at the church to review existing conditions from the newly erected scaffolding. Present were the full building committee, and Josh Jaskowiak (left in photos 2 & 3), Camden Crittenden and Klaudia Bak, all from WJE, and Ben Pear, mason (right in photos 2 & 3). Review of site conditions and discussions of scope.

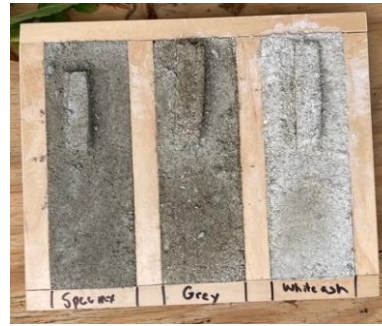
Site meeting to discuss options for mortar type, color and application, as well as cast stone type and color. Ben prepared a board with samples and prepared sample areas of wall.

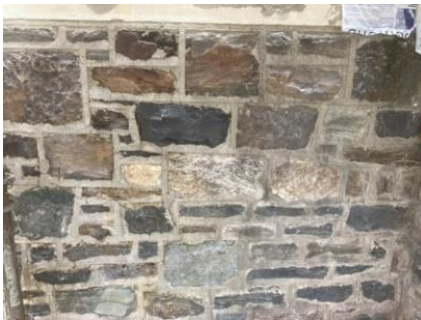
Cleaned stone wall section at left

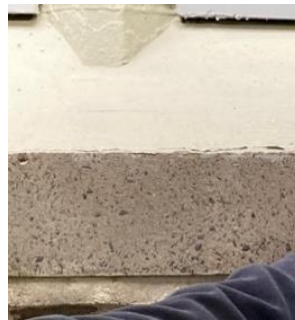
Original (1917) cast stone – cleaned section at bottom

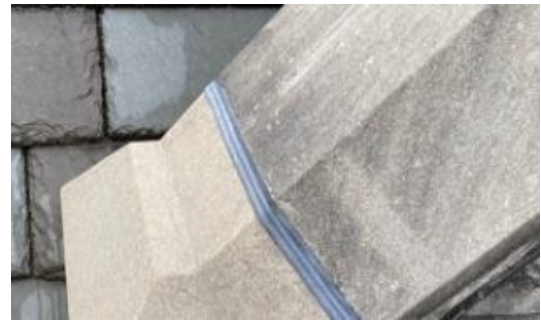
New (2015) cast stone – cleaned section at left

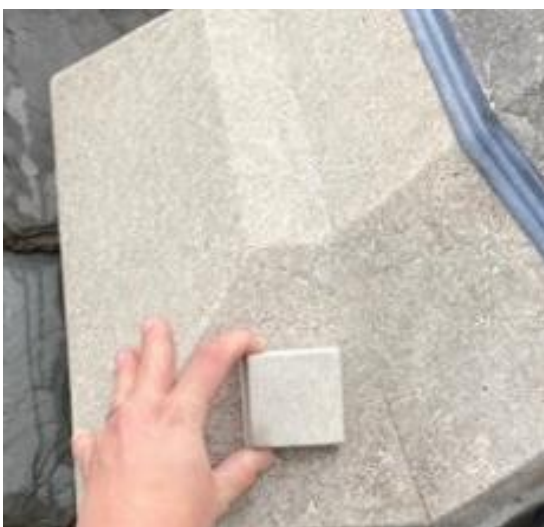
The photo to the left shows a sample of # 302N held against a cleaned section of new (2015) cast stone. When considering this comparison, an important point to keep in mind is that the clean section of the 2015 cast stone has weathered since it was installed, even though it was only nine years ago. As a result, some of the “fines” in the cement have washed away, revealing larger pieces of aggregate – as opposed to the sample, which therefore presents a smoother and less “grainy” surface. Another important point is that the cleaning did not remove all dirt staining. Thus, Ben smudged the lower left corner of the sample so we could see how it compares (this is visible in the photo). Taking these points

into account, Josh, Ben and the building committee all agree that # 302N is the closest match, and it may even be exactly the same (we have not found in the archives a record of the specific cast stone used in 2015, so we can't verify this possibility).

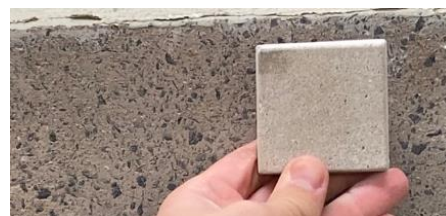
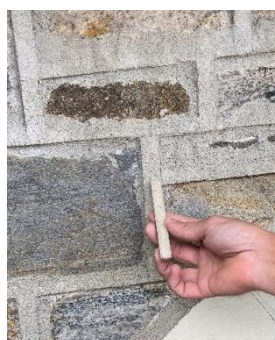
As for the mortar, at the site it was clear that mortar with an added pigment called “limestone” coloring would best approximate the color of most of what is currently present, especially when considering the likelihood of it darkening with age (see photo to right). Alternatives seemed either too dark or too light, as in photo at far right).

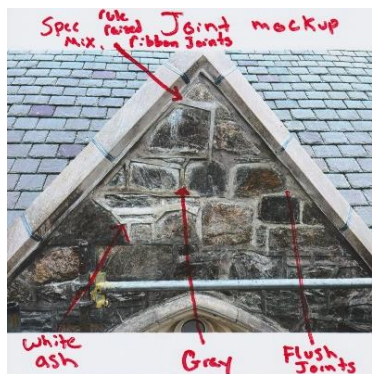
Below right is a photograph that Ben took of his trial mortars and labelled. It indicates both the different types of mortar under consideration and the different applications (extruded is on the left and flush is on the right). The center photo below shows Josh and Ben inspecting the trial mortars, and the photo below on the far right shows Peter Talbot, Klaudia Bak (of WJE), and Josh deliberating.

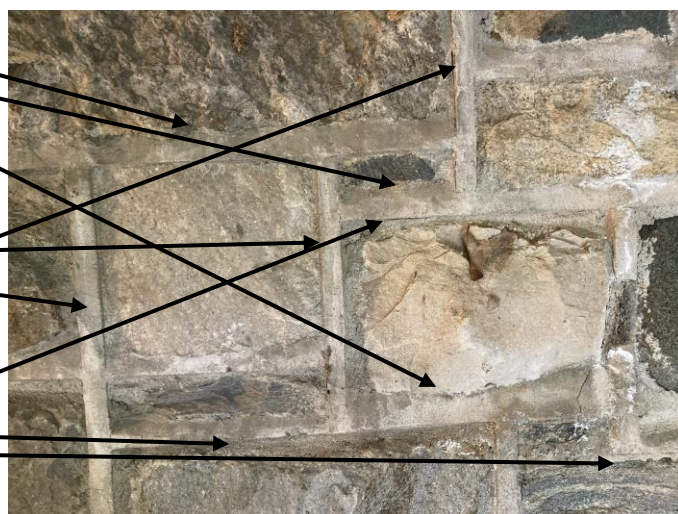
Note how top of joint is flush to surface of stone.

Mortar is then built up to extrude.

And a raised edge is formed on the lower side so water drops away from mortar.

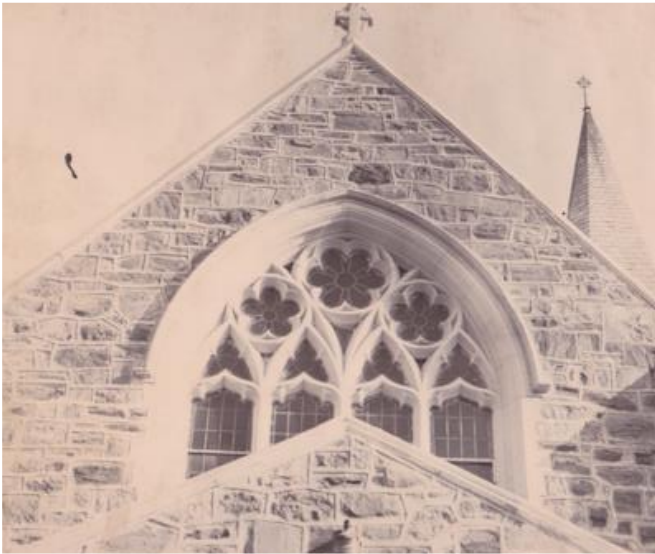
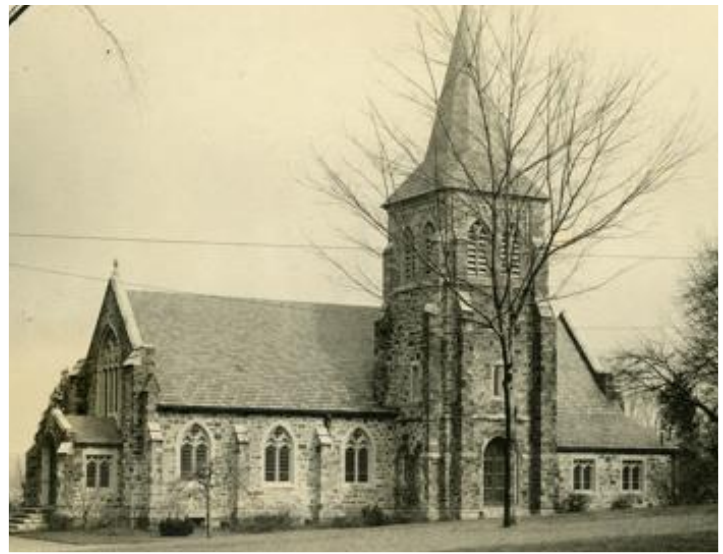
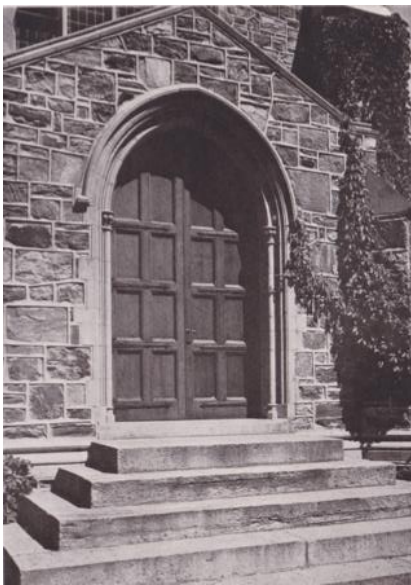
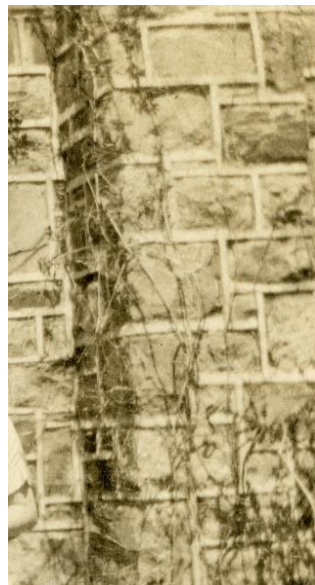
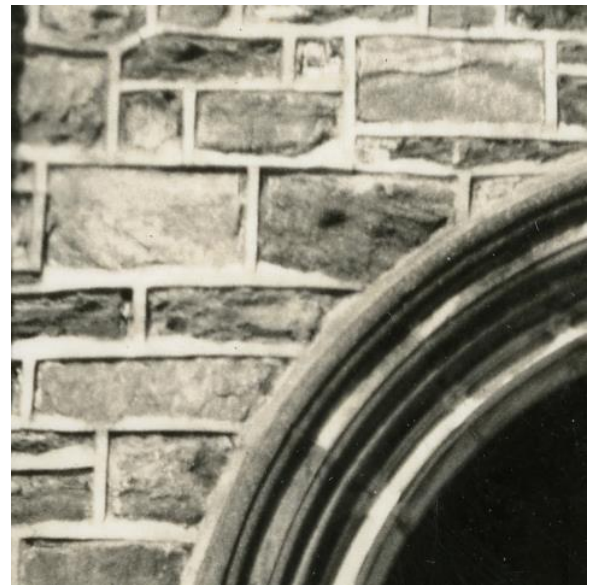
Old photographs provide more testimony to the original treatment of mortar. As you can see in the examples that follow, the original treatment had pronounced extrusion.

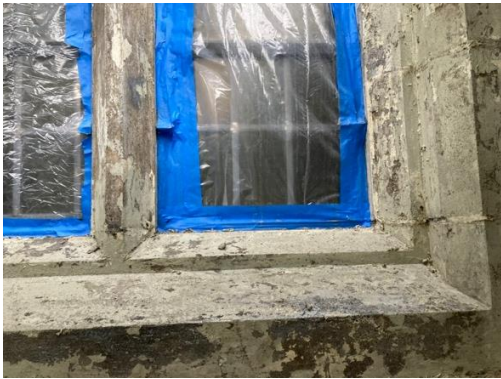
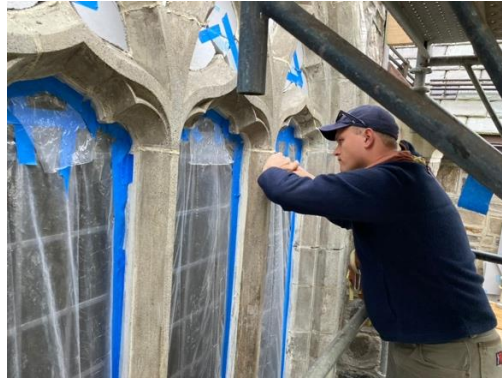
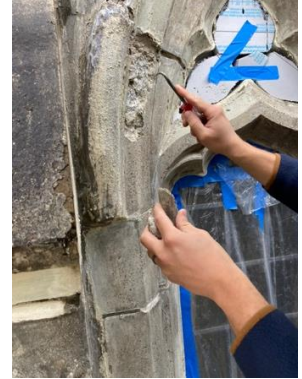
The photo below to the left documents ongoing coating removal. The middle and right photos show Josh testing a spalled section of tracery.

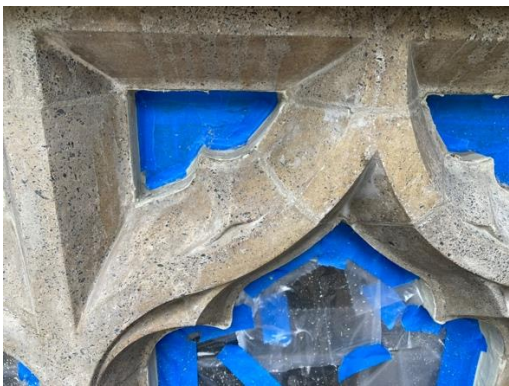
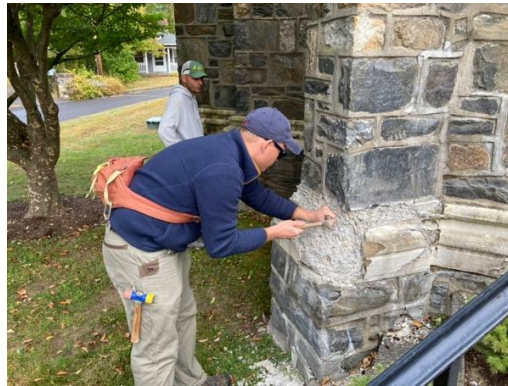
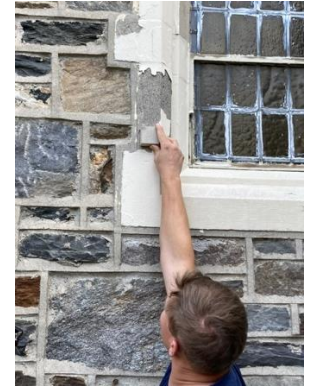
Below left is original tracery cast stone with coating removed. The surface is very smooth. In the middle is Josh testing water table cast stone spalling, with Ben in the background. To right below is Josh holding up the sample piece of cast stone # 302N.

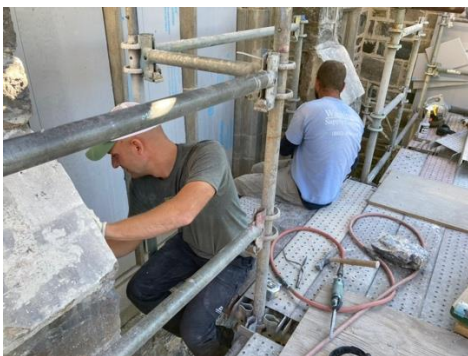
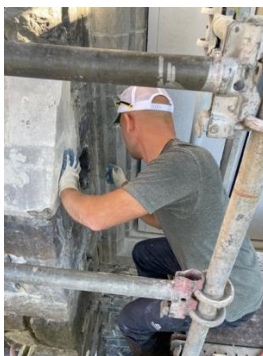
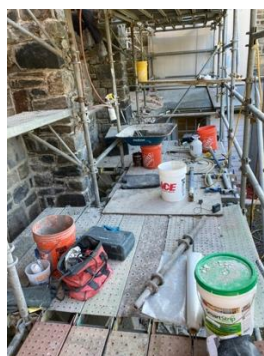
Worth visit to Ben and Pete at site. Below right is an area of wall where the old repointing has been scraped out and it now awaits repointing.

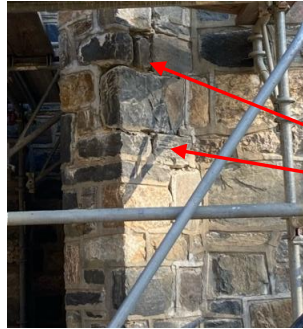
Some of the damage to be repaired is clearly visible here.

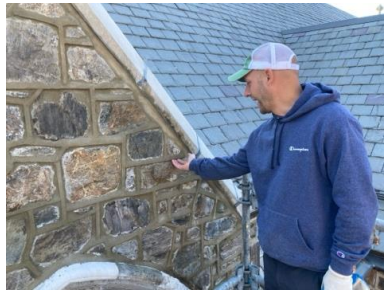
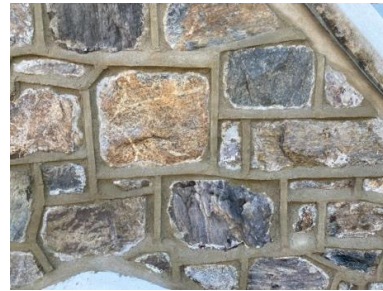
Photographs above are of the repointed gable, the first section to be addressed.

What's really thrilling is that Ben and Pete have started to repoint. After the time spent planning, raising initial funds, setting and revising goals, reviewing contracts, and working and meeting at the site to prepare (as detailed in part above), to see these joints repaired and sculpted into such an aesthetically pleasing surface sparks unexpectedly strong feelings of happy exuberance. Our dear stone church, so recently under such duress and appearing worn and broken, now looking so pert and dapper again – a gladdening sight indeed!

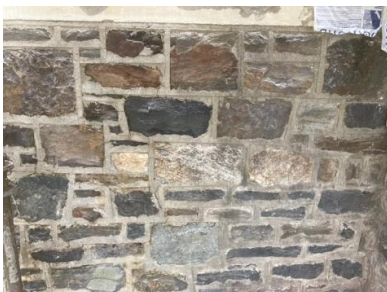
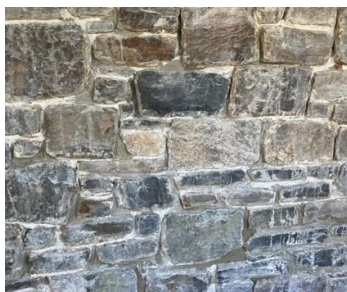
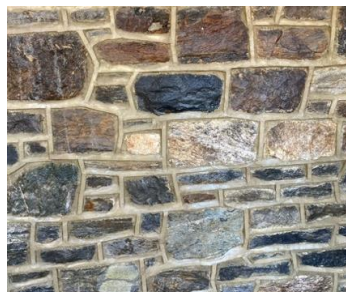
Below is a section under the window on the north chancel wall, before repointing. Wall surface to the left in this photo has been cleaned, but otherwise this area appears as it did before the project commenced. Middle left is the same section of wall during cleaning and after joints have been scraped in preparation for repointing. Below right is the repointed wall and a detail of it.

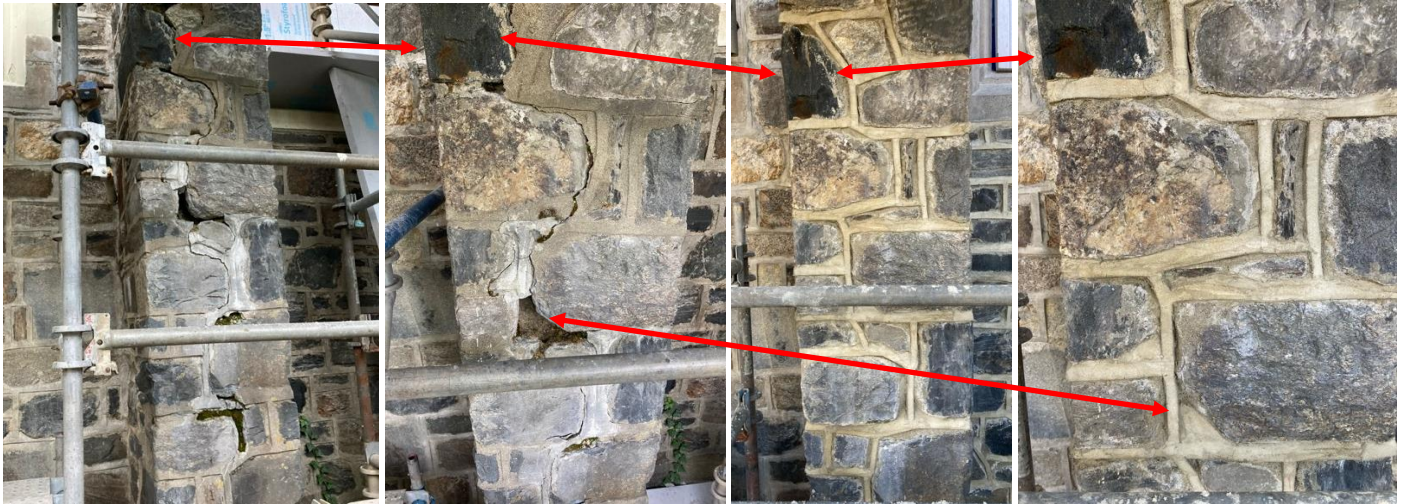
Below are before-and-after pictures of the left buttress on the chancel wall. Red arrows indicate corresponding sections between photos.

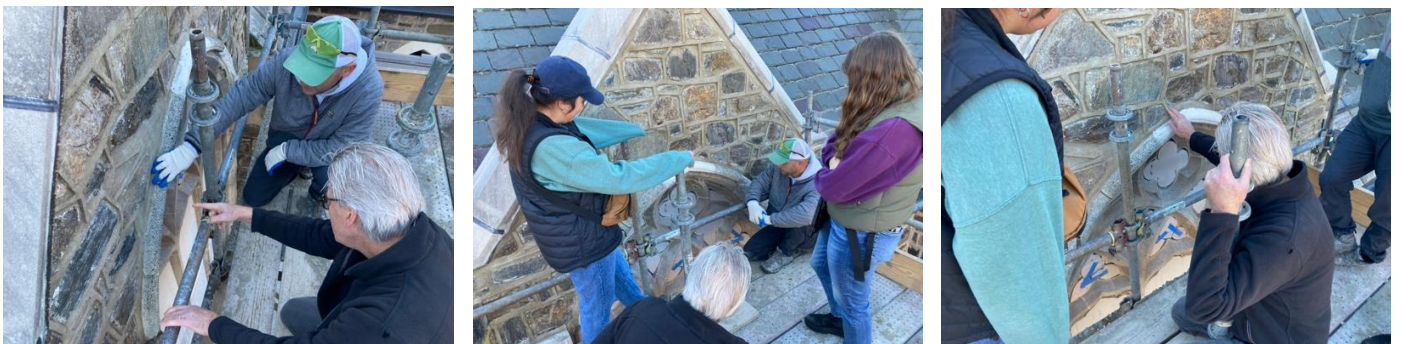
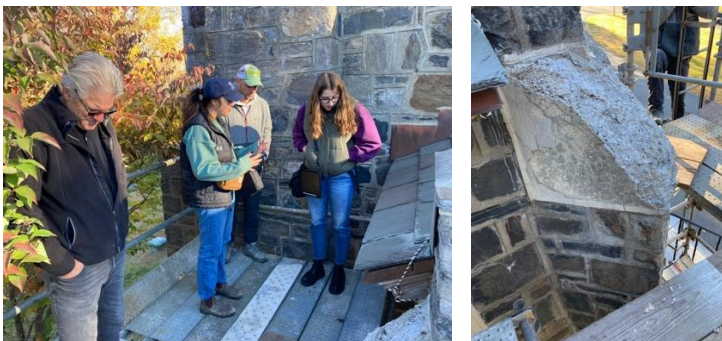
Site visit with Ben and Pete (BPM), Klaudia Bak and Camden Crittenden (WJE), Peter Talbot and Worth Bracken. Review, and discussion about window surrounds and tracery. Below are some photos.

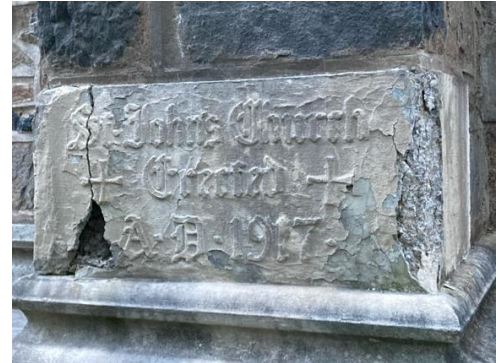
The near-ruinous cornerstone today
